# Hints from the Model Garage

## More Hints from the Model Garage

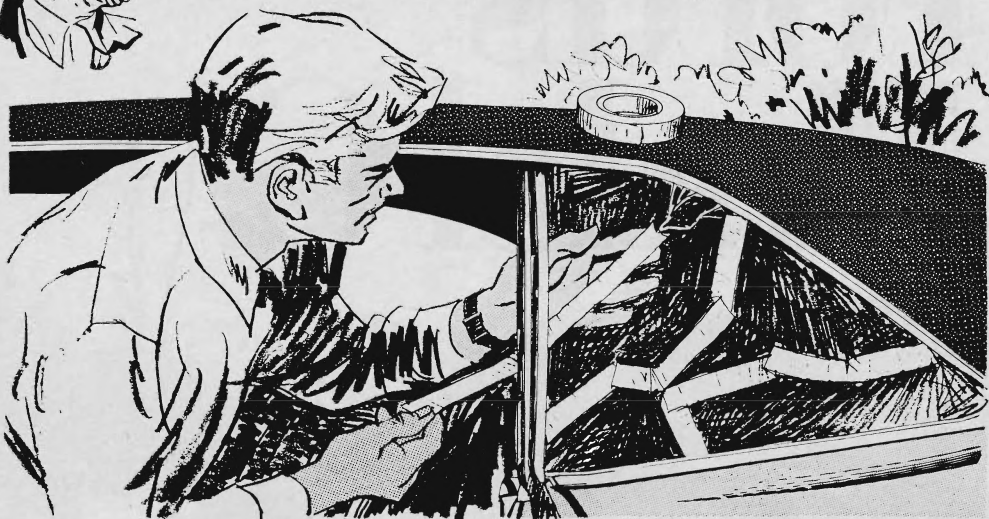
When a glass panel is broken and a replacement job can't be done right away, here's an easy way to keep the fractured glass in place temporarily. Tape the cracks, inside and out, with masking tape. This make-do is safe as long as the window is not lowered and raised

too frequently. When replacement can be made, the tape will hold the whole glass panel in one piece during removal. There will be no sharp bits or slivers to cut your fingers or damage the car's paint or upholstery. Clean window frame before inserting new glass.

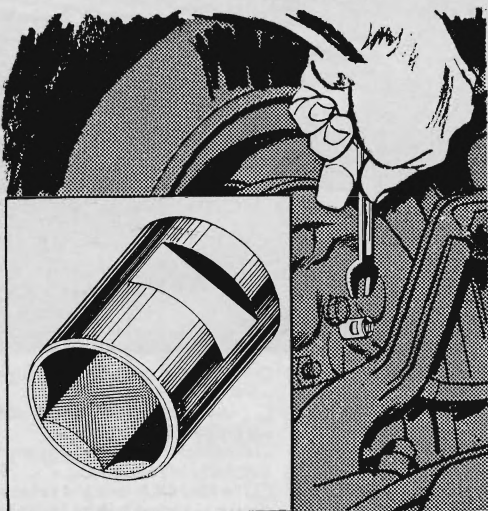
The  $\frac{1}{4}$ " bleed screw on late-model Falcons and Fairlanes is too close to the spindle to let you get a socket wrench and handle in place. The screw is also too small for a normal wrench. Grind two flats on the outside of a  $\frac{1}{4}$ " socket to fit a  $\frac{7}{16}$ " open-end wrench.

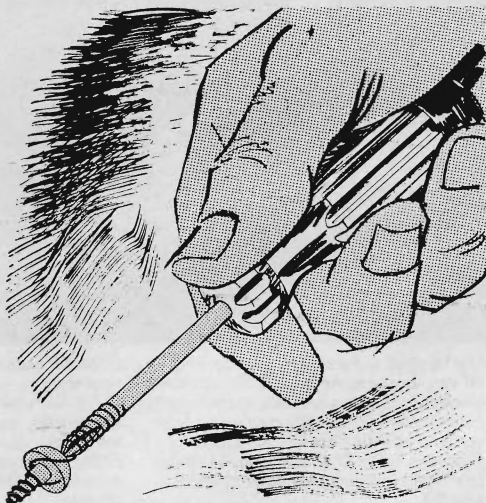
To fit a Phillips screw in a tight place, you often need to mount it on the tip of the screwdriver. To keep it from falling off, fit a small coil spring around the blade and bend the coil out to catch the screwhead. After starting, turn back half a turn to free the spring.

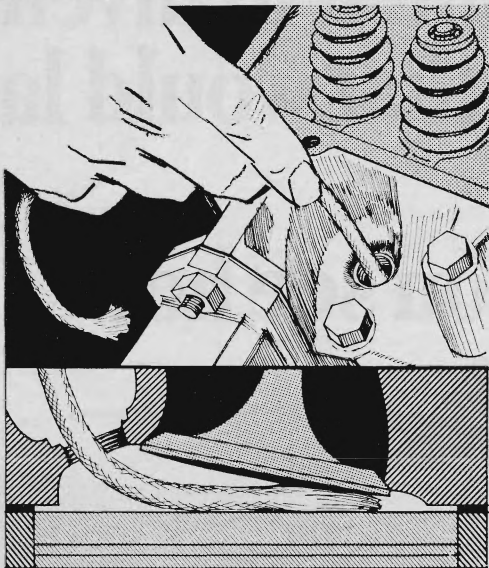
To replace neoprene valve-stem seals you must remove the valve springs. The manual says to use air pressure through the spark-plug hole, with the piston at top dead center, to keep the valve from dropping. If you have no air pressure, drop in a clothesline end.

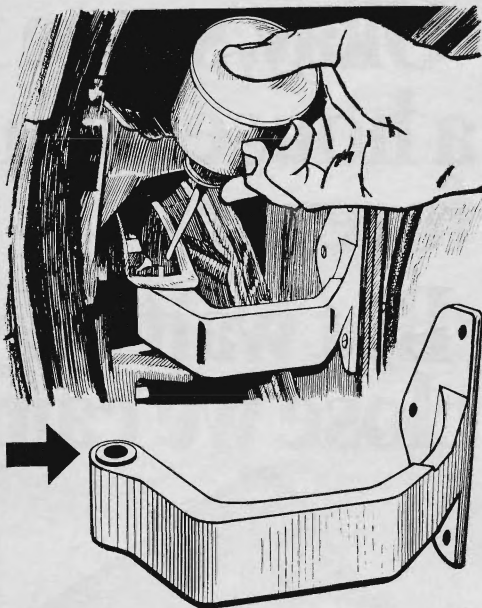
Plastic bushings in the door hinges on Fisher bodies rarely bind. If they do, the best way to free them is with a few drops of transmission oil. This does a quicker job than any lubricating or penetrating oil. Some oils seem to make the bushings bind worse than before.

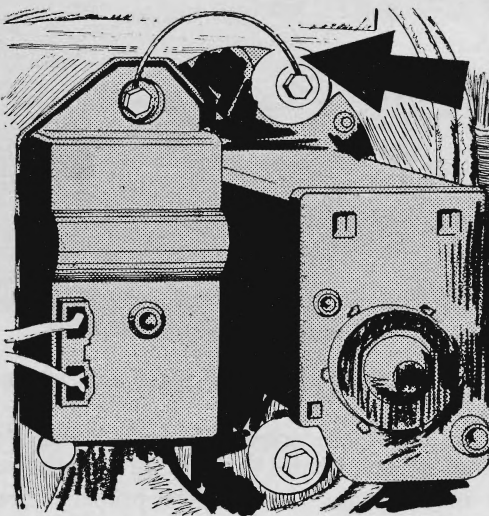
**Radio interference** in some cases can be traced to improperly grounded two-speed wipers. Here's a simple way to provide proper grounding: Install a 14-gauge stranded wire between the switch plate on the wiper motor and the motor mounting plate.

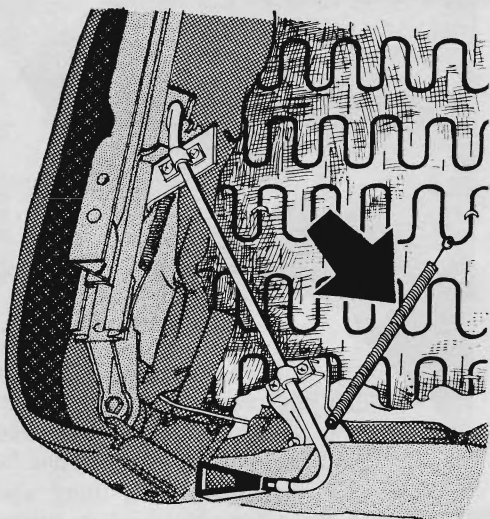
**Rattles from front bucket seats** may be caused by the adjusting handle fouling the seat frame. Fix it by fitting an accelerator retractor spring between the handle rod and one of the seat springs. The handle will remain quiet when the car is on the road.
